Site Restoration Challenges at FOX-C – 2007 Update

April 29, 2008

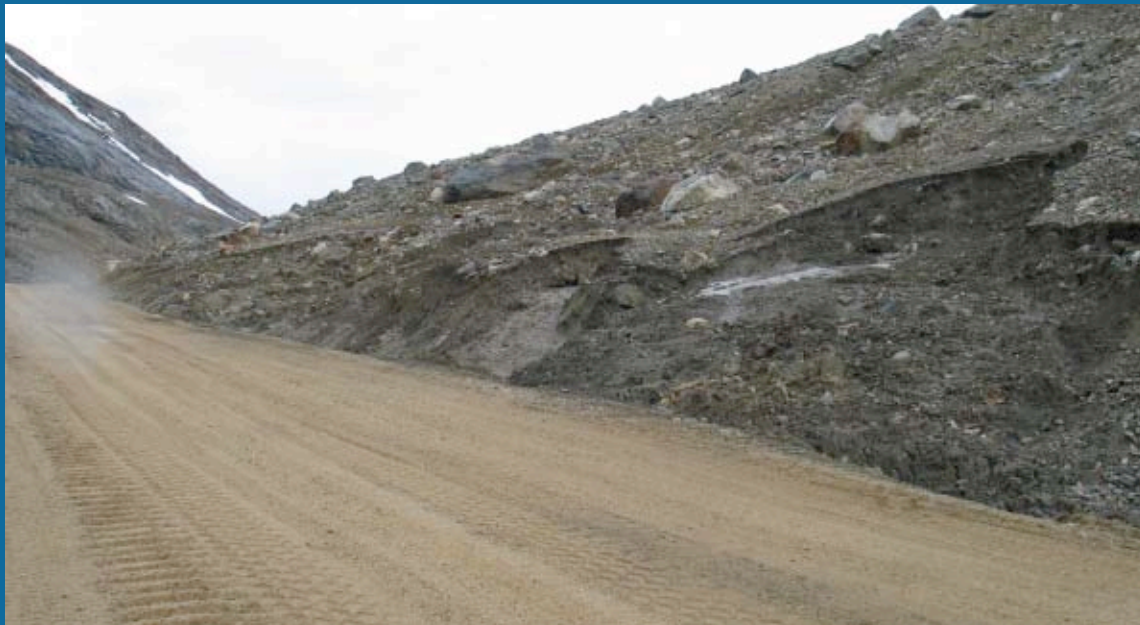
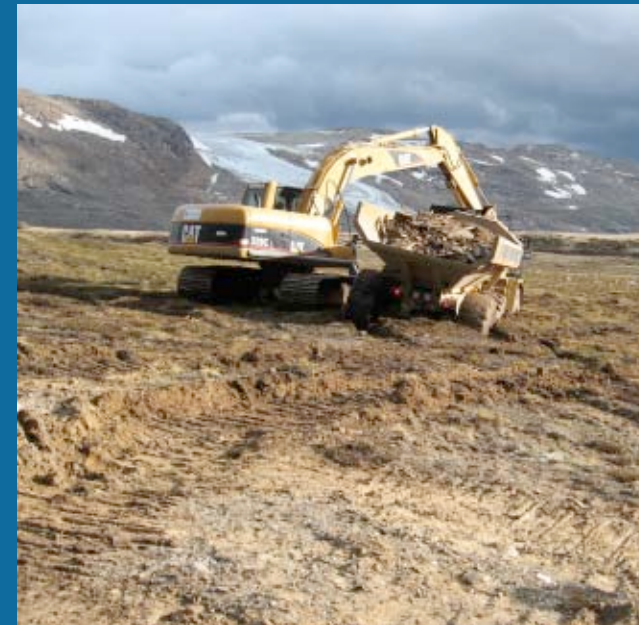
Active Layer Instabilities

- Active layer 0.6 m to 1.5 m
- Native soils at the lower site are sand, silts and gravels; slopes dominated by colluvium
- Removal of thermal cover problematic
- Previously disturbed soils

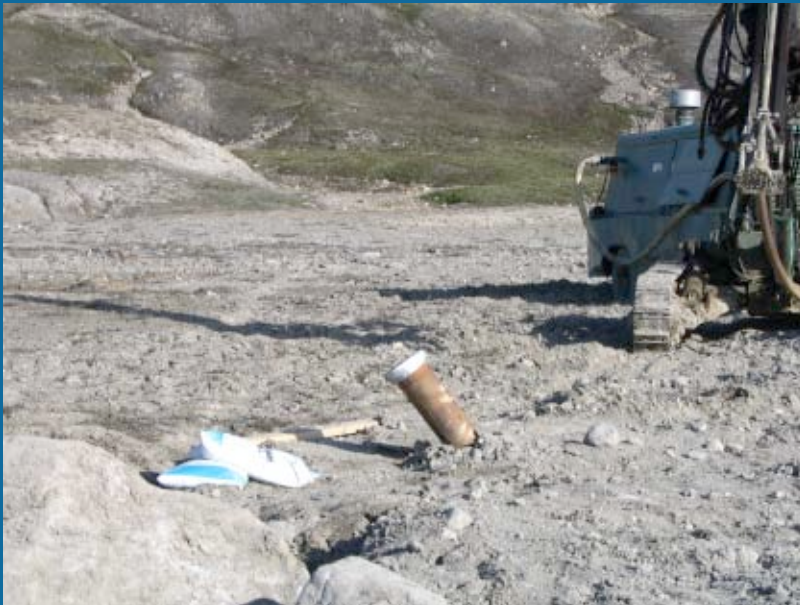
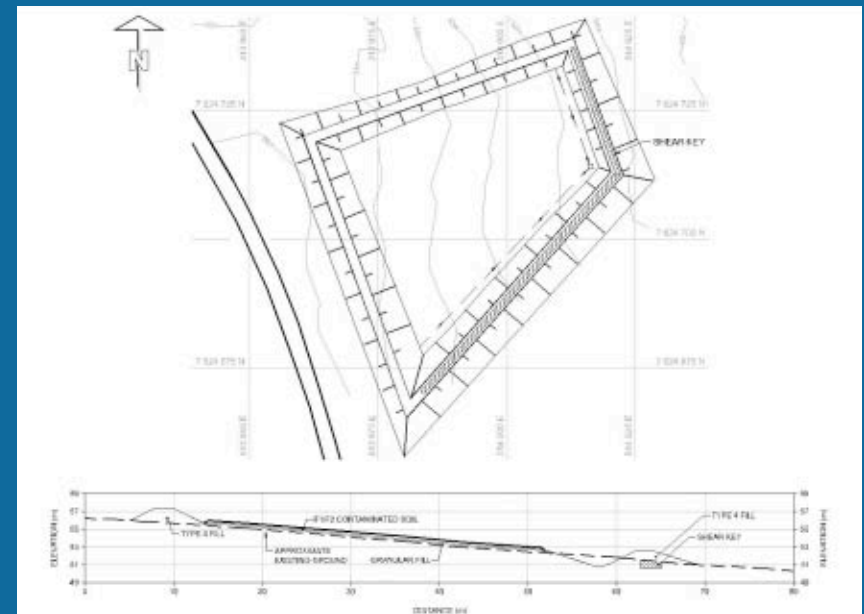
Landfarm

- Situated at lower station on a long, gentle slope
- Movement occurred after completion of the east berm
- Ruptures at toe and tension cracks noted – shallow slab failure
- Shear Keys incorporated in berm repairs
- No additional movement noted in 2007

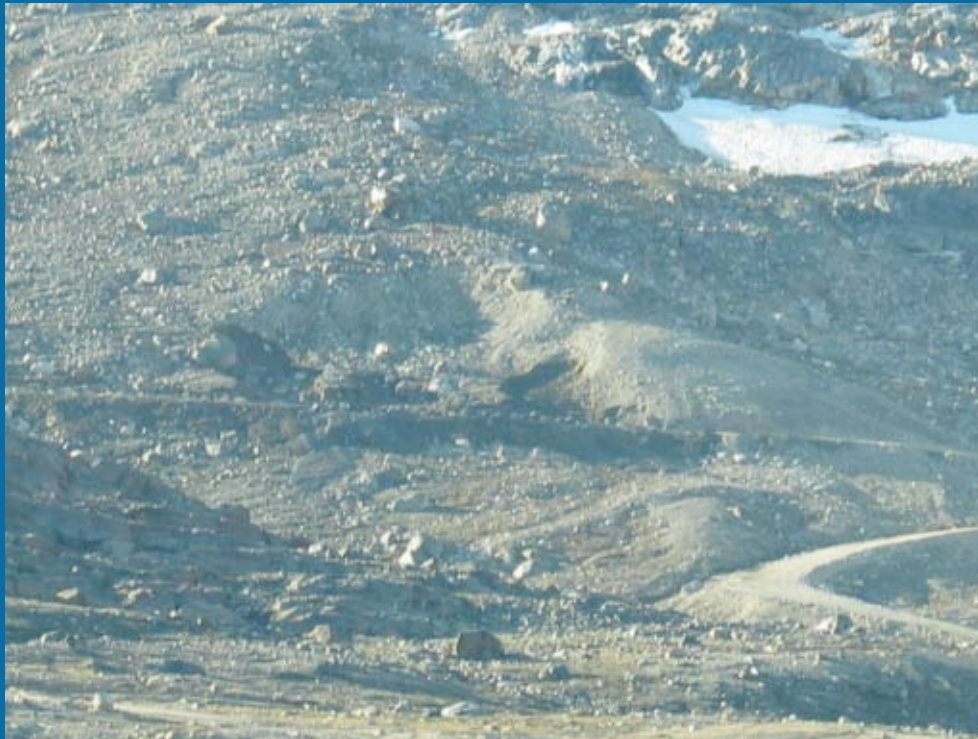
Slope Failures

- Slope failure occurred along road to upper station in 2006
- Occurred after ditching exposed permafrost and removed toe support
- Same failure mode noted throughout the site
- Generally cooler temperatures in 2007 plus equilibrium of slope may have contributed to stability in 2007

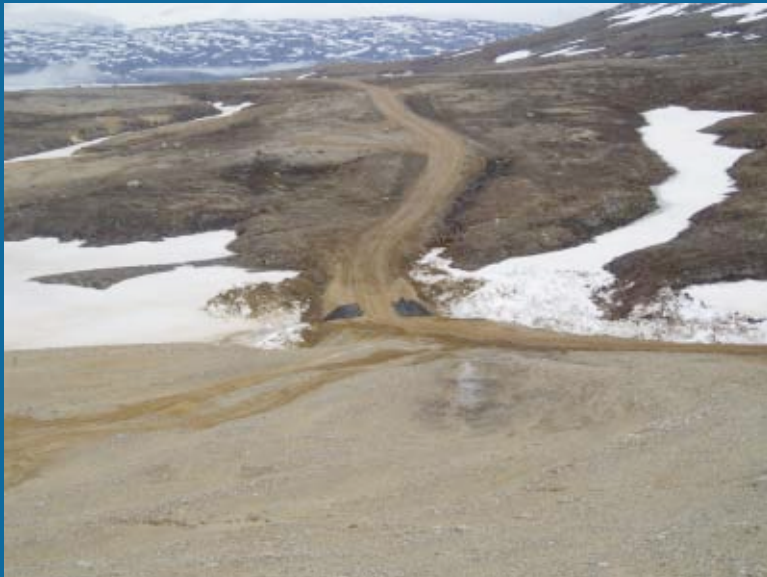
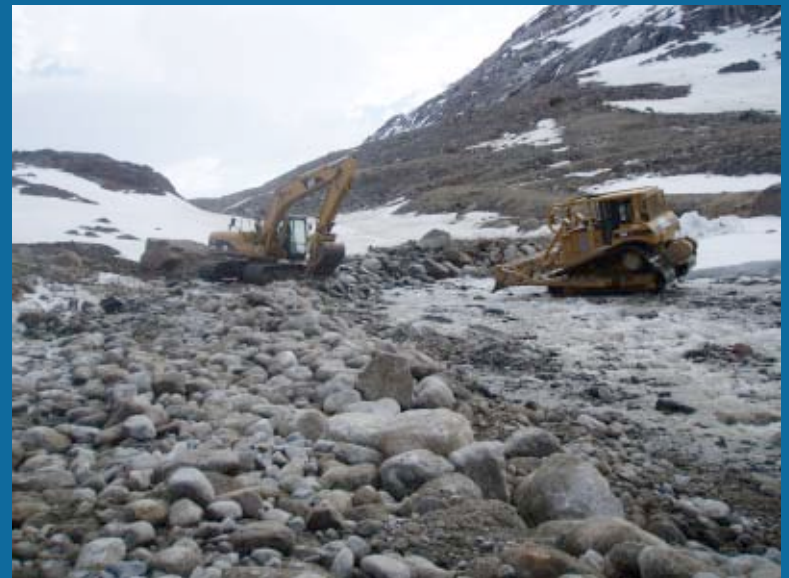
Road Construction/River Crossings

- The original road had deteriorated such that it was impassible by ATV – considerable effort went into upgrading in 2006; only maintenance required in 2007
- Ditches provided short-term stability by draining active layer; generally contributed to long-term road stability
- Wet subgrades caused fine-grained soils to migrate into the granular road fill

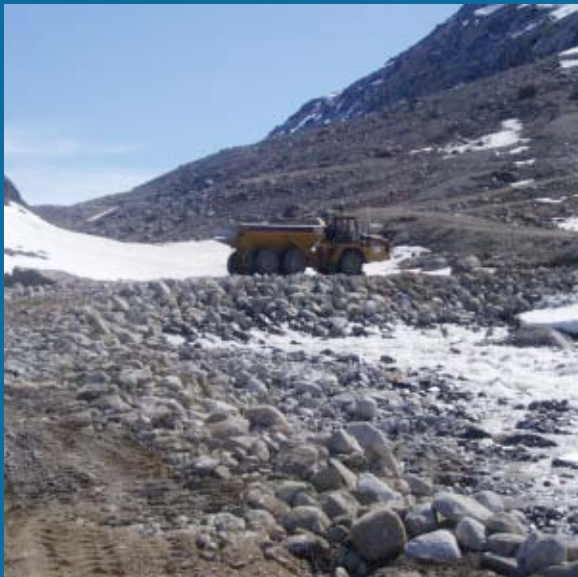
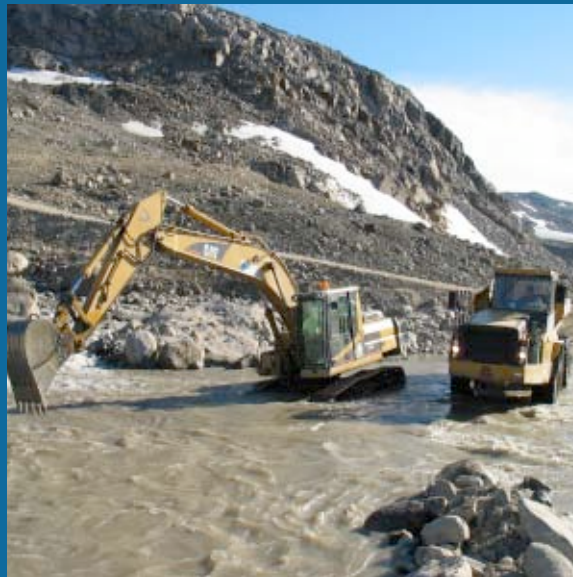
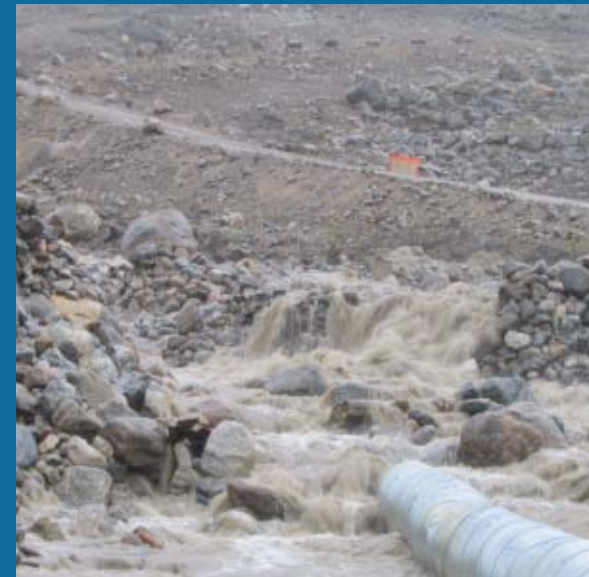
Road Construction/River Crossings

- River Crossing 1 designed as a porous embankment
- High sediment load caused pore spaces to fill with sand
- Breached during heavy rains in August 2006
- River Crossings 1 & 2 redesigned with culverts
