# ***The Link Between Tailings Pond Gas Generation and Variable Ice Conditions***

## Colomac Mine Remediation Project, Northwest Territories

2012 RPIC Federal Contaminated Sites National Workshop  
Toronto, ON April 30-May 2, 2012

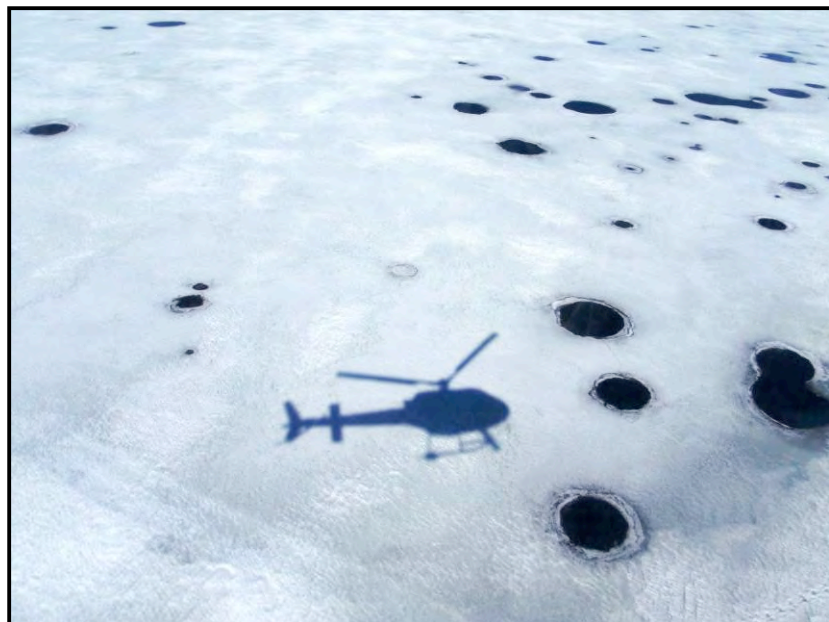
Aerial view,  
Spring

- Gas generation has been observed in Tailings Lake over the project life
- Bubbling occurs in distinct vents and is characterized as either consistent or intermittent
- Open vents have been observed in aerial and ground level photos taken during winter months
- Variable ice formation and quality have been observed over short distances

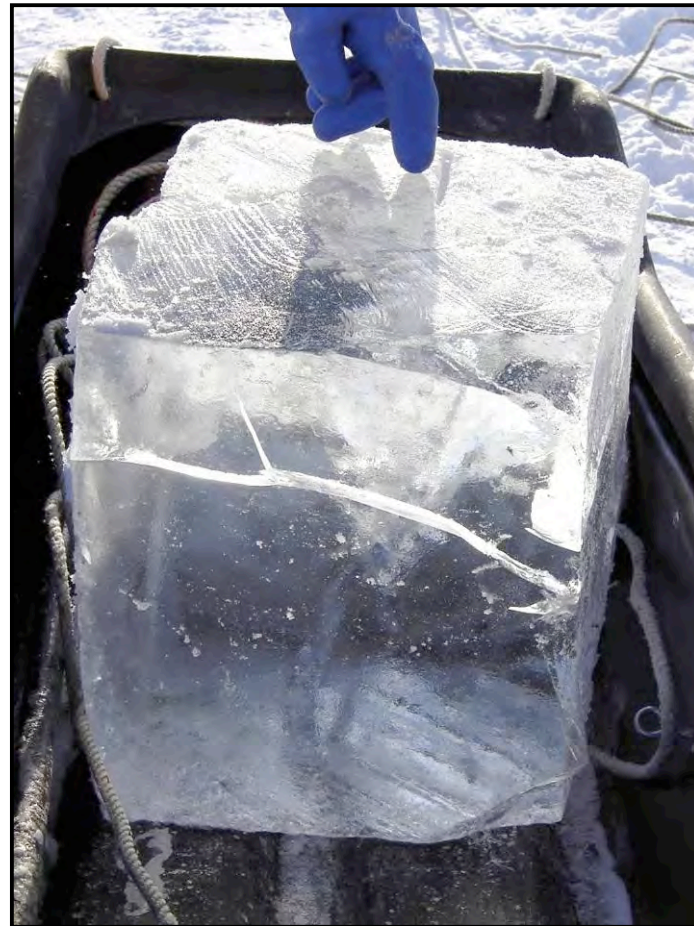
Good Ice Quality – Blue Ice

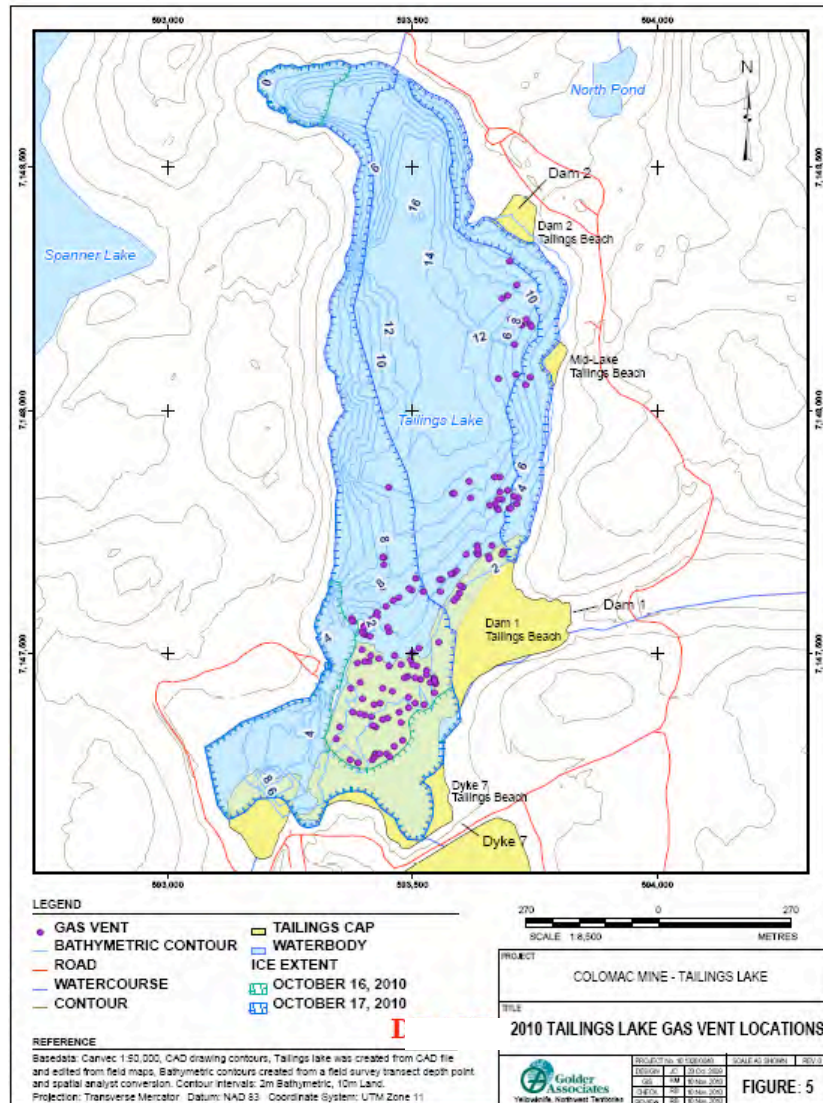
- Gas generation primarily associated with and/or down gradient of capped tailings
- Gas venting occurs to lesser extent in the capped mid-lake tailings beach (East shore)

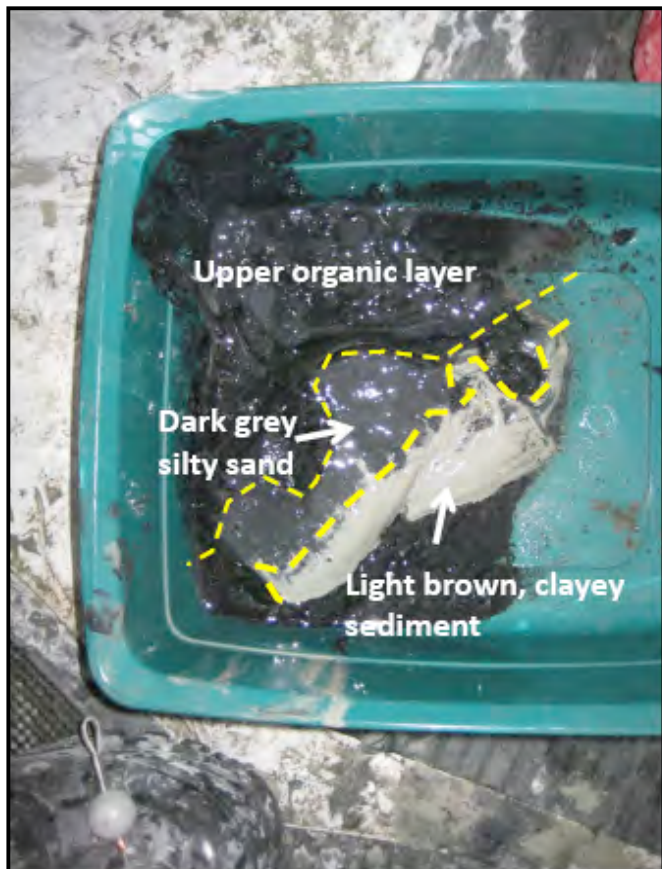
- Upper Organic Layer – deposited during ENR
- Mid layer – fine grained tailings deposited during mine operations
- Basal layer – native lake bottom sediments
- Iron bacteria, slime – forming bacteria, sulphur reducing bacteria identified in all three layers
