Site Restoration Challenges at FOX-C – 2007 Update

April 29, 2008

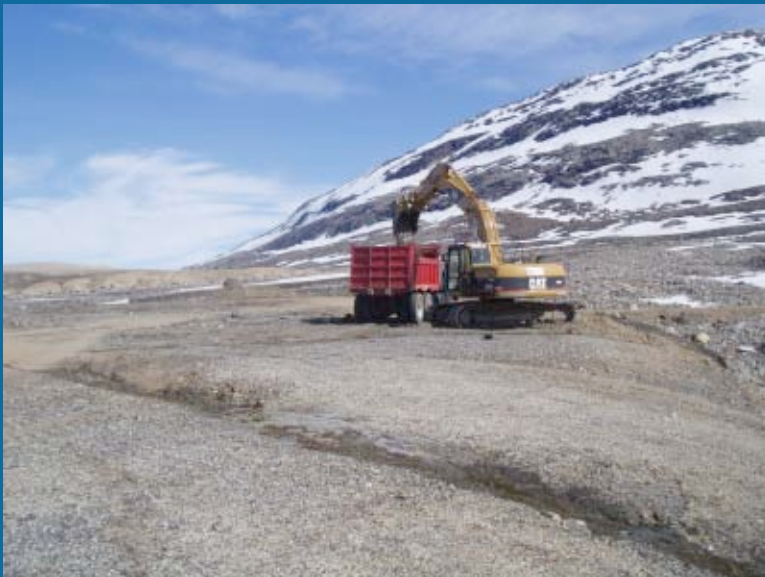
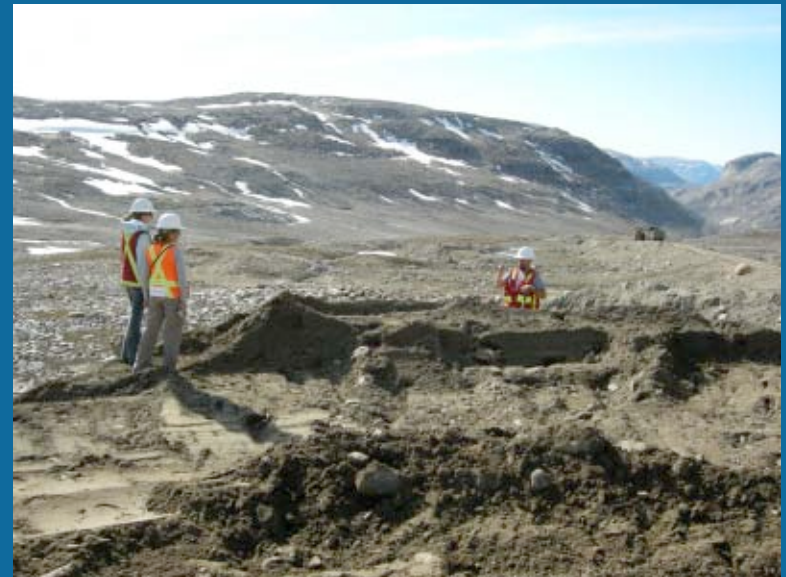
- Borrow material at FOX-C obtained from natural deposits
- Considerable effort to find additional borrow areas
- Borrow areas developed in 2006 and prepared for 2007 were not necessarily usable
- Introduction of Type 1 (cobbles and boulders) fill to mitigate high moisture of some borrow areas
- Contributed to revision of Upper Site facilities

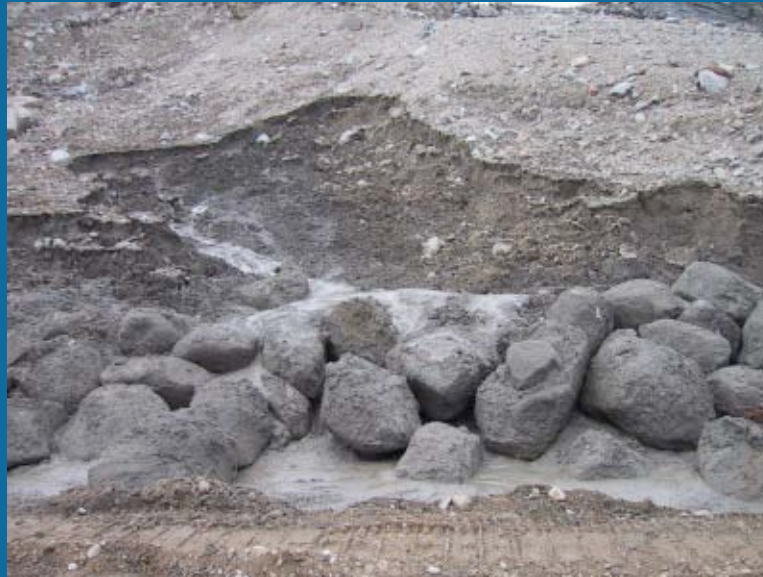
- Fine-grained saturated soils at FOX-C are especially prone to movement
- Low-strength slip planes at the base of the active layer provide a preferential location for slope failures
- Shear keys are effective measures for stabilizing embankments
- Removal of toe support can create slope failures that are difficult to control

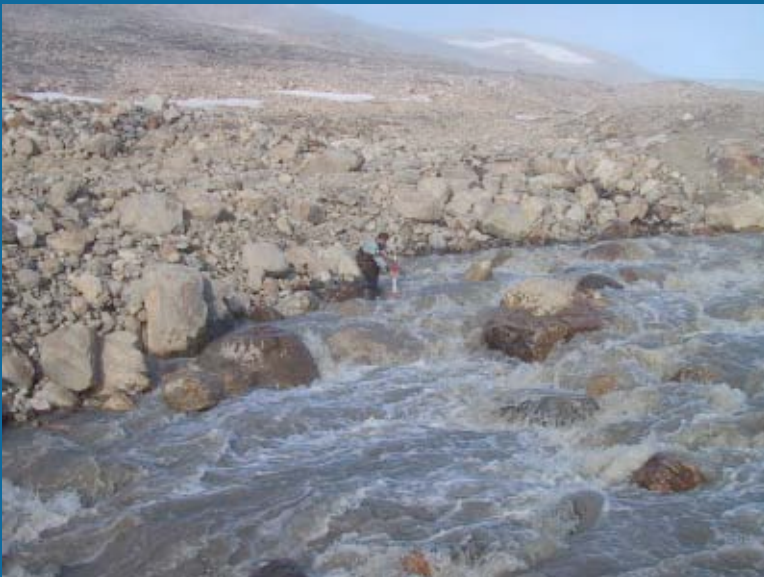
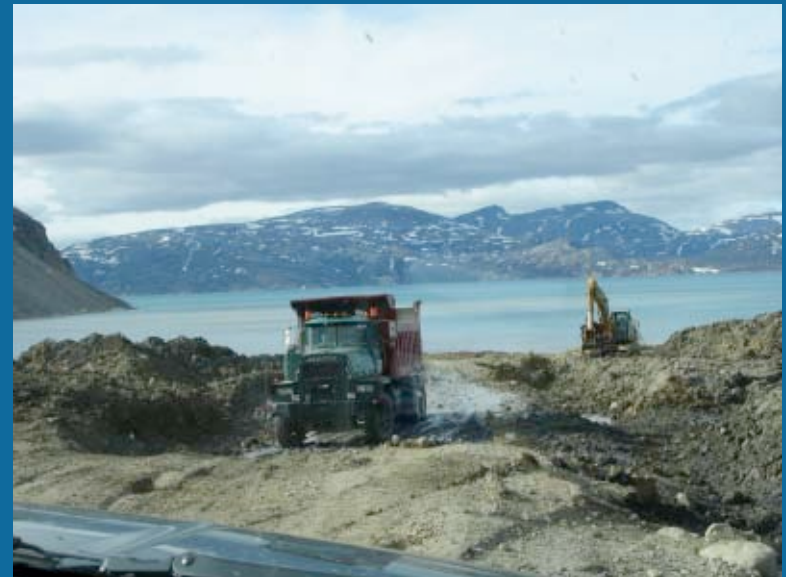
- Design of porous embankments should consider high glacial sediment load; 2007 culvert embankments performed adequately
- Ditching provides short-term stability for roads, but exposes more permafrost, which could introduce seasonal stability issues
- Ditching likely alters permafrost level, and road instabilities may be seasonal
